NASA Technical Memorandum 84637

AVRADCOM Technical Report TR-83-B-1

FLIGHT SERVICE EVALUATION OF COMPOSITE COMPONENTS
ON BELL 206L AND SIKORSKY S-76 HELICOPTERS

DONALD J. BAKER

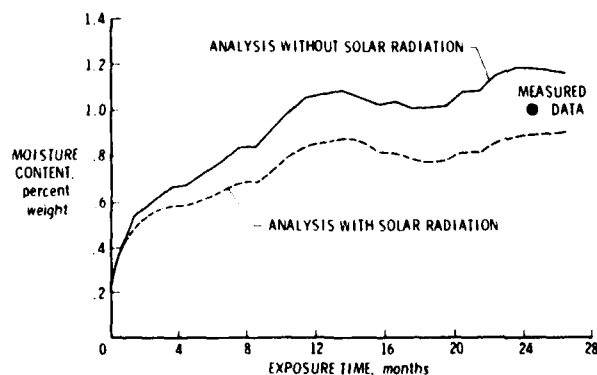
Figure 16. Moisture Absorption of a 6-ply Graphite/Epoxy Panel Exposed At West Palm Beach FL.

The environmental panels were removed from the Stratford, CT and West Palm Beach, FL (WPB) locations after 2 years of exposure. Data on moisture absorption are presented in Table 8 and figure 16. The 5-ply Kevlar-49/epoxy panel absorbed the most moisture (1.6 percent) whereas a 33-ply graphite/epoxy panel absorbed the least amount of moisture (.18 percent). The average monthly weather data for both locations and predicted moisture content are given in reference 3. Moisture absorption data for the 6-ply graphite/epoxy specimens are compared with predicted moisture absorption in figure 16.

The measured data is approximately midway between the two predicted curves which differentiate the effect of solar radiation.
